Final Report
STUDY THERMOGRAPHIC FLAW DETECTION

Contract Number: NAS8-38609

July, 1996

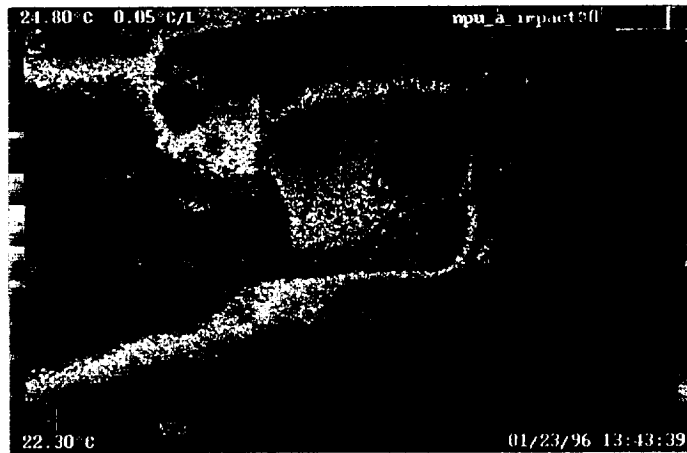
Figure 14. Impact coupons in NPU-3.

To better test how well the thermographic procedure used to inspect the nose cone would identify such an impact, two of the impact samples were clamped to the inside of a cut out region of the NPU-3 and inspected. Figure 14 shows the thermal image from that test. It is clearly evident that the inspection process is capable of identifying impact related damage and that the scheduled Teflon insert defects do to some degree behave thermographically as artificial impact damage.

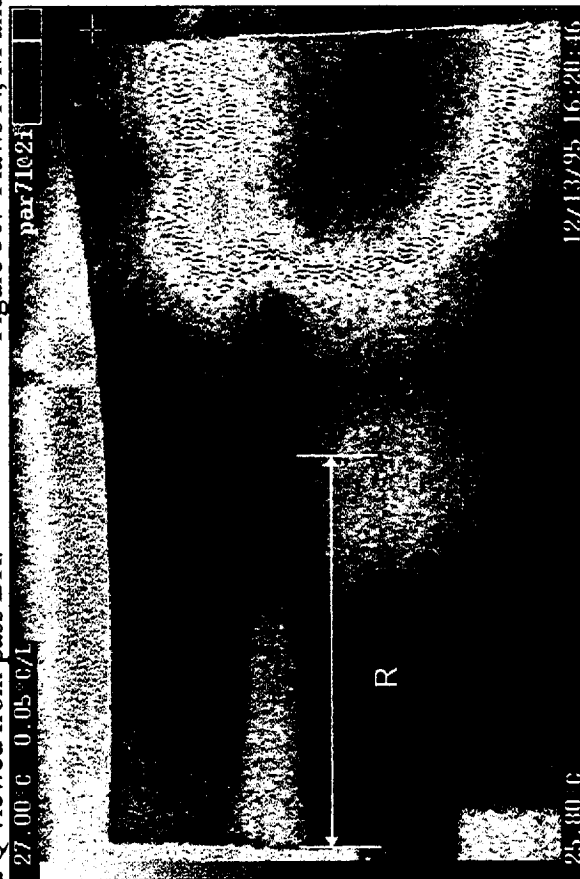
Figure 31. Scan "AR".

A long rectangular feature extending nearly half way across the panel was found during pass “AR” that was not apparent on the surface of the panel (Figure 31). Without any knowledge of the make-up of the panel in that region it is hard to tell if this is a defect or not. Since, a similar feature was not found on the other end of the panel during pass “B” or “BR” it is suspicious.

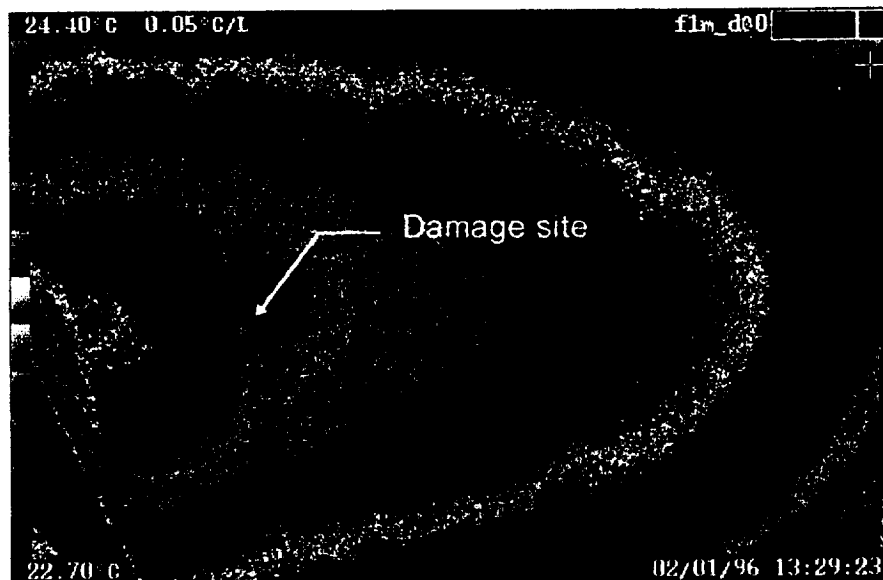
Figure 59. Thermogram of damage on nose cone F1.

A tool had been dropped on the inside of the nose cone during the machining process that left a small visible mark. Special attention was given to Pass “D” since it would overlap the impact site. Based upon the thermographic results, the damage appears to be only superficial. The following figure shows the impact site as a small aberration along a seam line. A hand scan of the region, with higher magnification, also showed no thermal indications of delamination due to the impact. The remainder of the F1 nose cone showed no thermographic indications of damage.

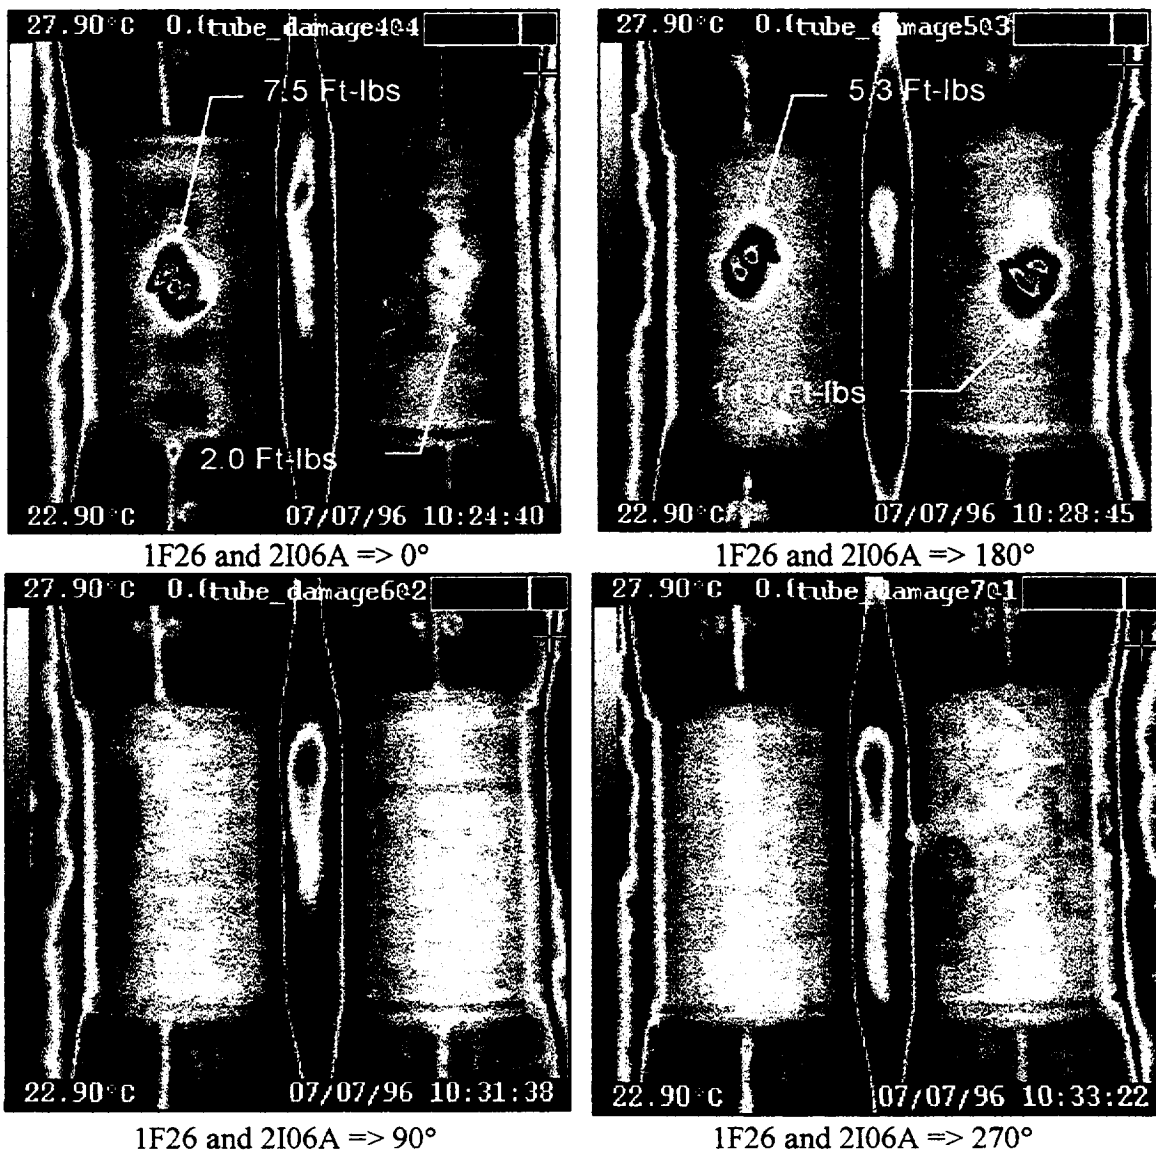
Figure 60. Impact damage in gr/ep tubes.

The ability of the imager to measure damage in the tubes was tested by inflicting, impact damage at the 0 and 180 degree mid-length points (Figure 60).

All but the lowest (2.0 ft-lb) energy impact produced a hole at the impact site. The 2.0 ft-lb impact was barely visible on the surface. The thermal indication from the impact damage relates well with the impact energy, higher impact equating to a larger indication, just as was seen on the graphite/phenolic impact coupons (Section 3.0).

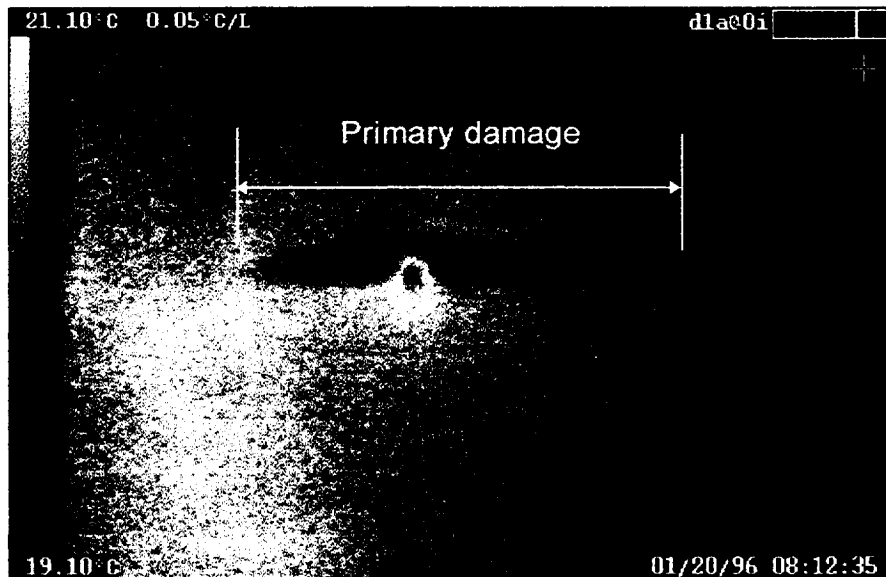
Figure 61. Image D1A of primary damage.

The thermographic image of the primary damage zone (Figure 61) closely resembled that which could be seen visually. That is, delaminations do not appear to exist beyond the region where the fibers have been damaged.

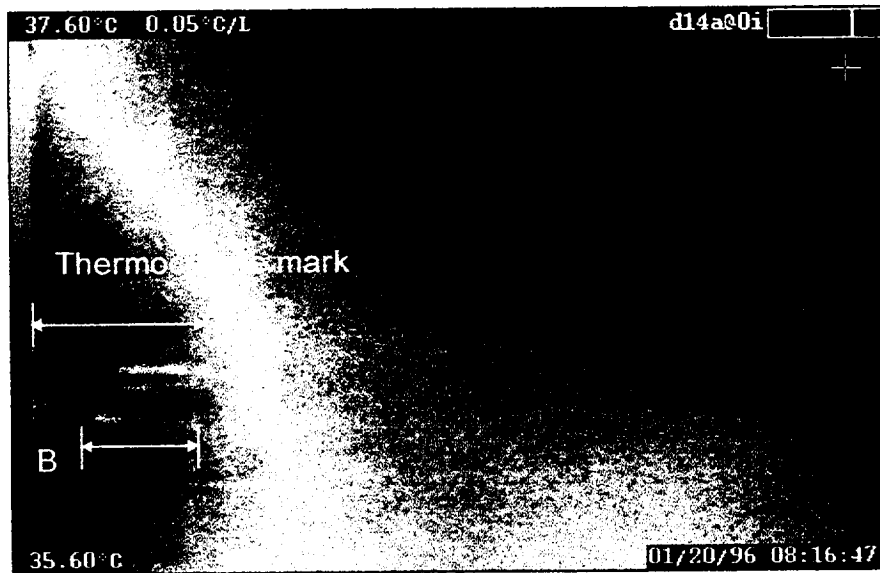
Figure 62. Image D14A of secondary damage zone.

A second damage zone (Figure 62), labeled B in the following figure, was found in region 14 just below a thermocouple mark. The majority of the damage appears to be at the transition between the thick and thin portions of the hoop region and then gradually reduce in magnitude toward the end of the thermocouple mark.

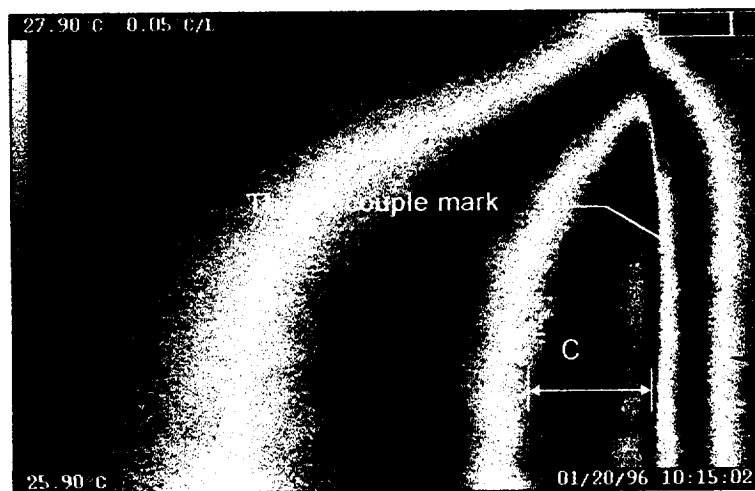
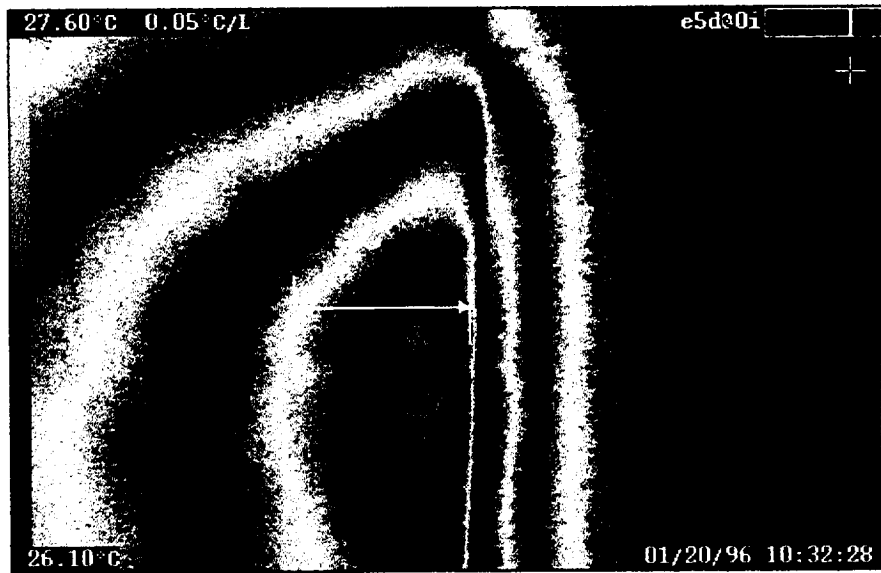
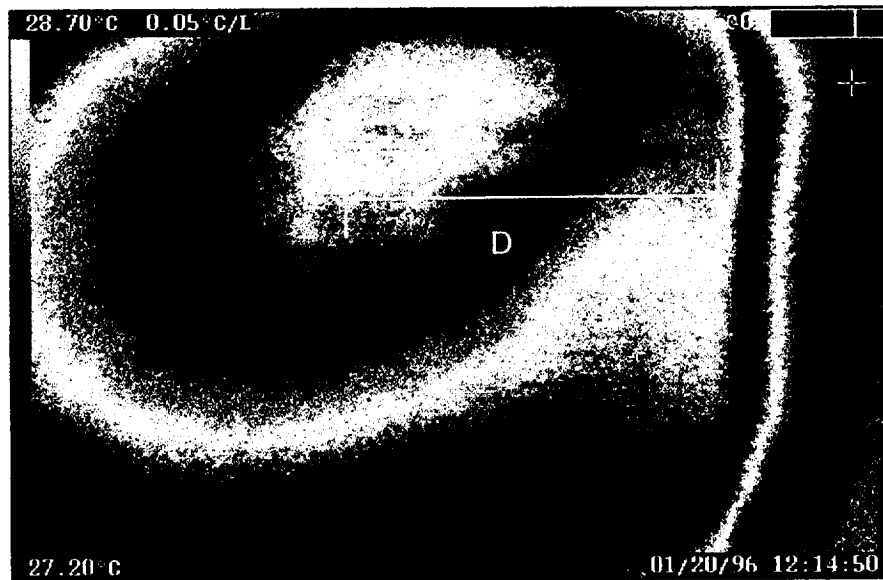
On the opposite end of the tank from the primary damage two small indications (Figures 63, 64 and 65) were found. These indications may be the result of the lay-up procedure, i.e. irregular overlapped layers, or an actual flaw site. Due to the magnitude of the indications it is unexpected that they would cause any structural problems, but have been included in this report for future reference if a problem develops.

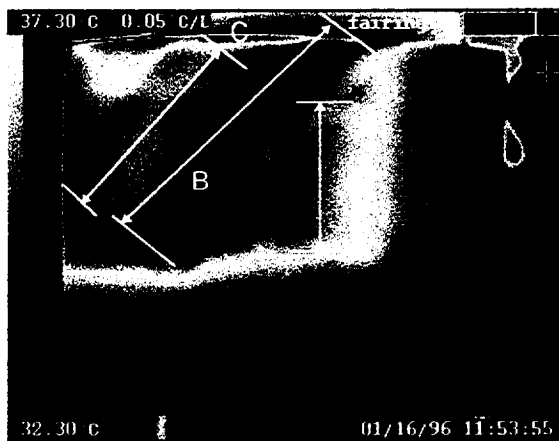
Figure 66. Outside of flange.

All of the indications were much weaker during the scan of the inside of the pipe as shown in Figure 67. Note that indications "B" and "C" show up as faint diagonal bands oriented down and to the right while indication "A" appears as a light region in the center of the image. Whatever is creating these indications must be closer to the outside of the flange since they appear brighter and more defined on the outside scan (Figure 66).
